Research on the Development of Pipeline Life Extension Plan

Appropriate stock management

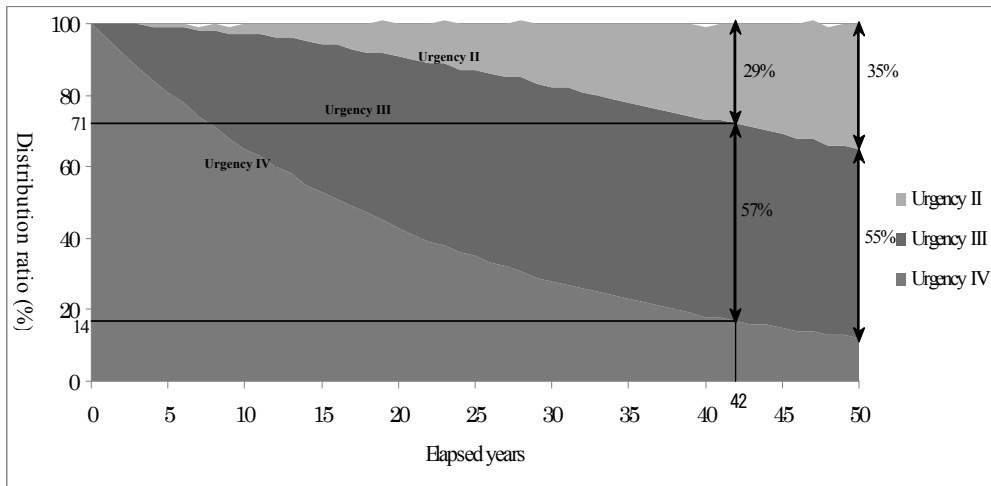
Figure-2: Distribution of Urgency levels

- (4) The deterioration degree of each sewer pipe has been estimated by applying the Markov transition probability based on the inspection results. According to the estimation, 29% of the pipes has been ranked as "Urgency II" at present (42 years elapsed after construction), and this ratio has been projected to increase up to 35% at 50 years after construction.
