Research on the Development of Pipeline Life Extension Plan

Appropriate stock management

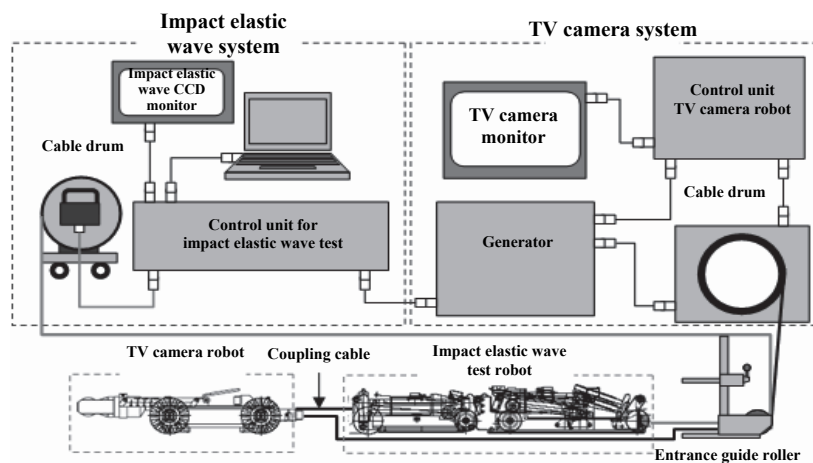
Figure-1: Outline of Impact elastic wave test

- (2) The interior of the pipelines was inspected by using a wide-angle TV camera and by conducting impact elastic wave tests as well (**Figure-1**).
- (3) In A City, the conditions of pipelines were determined to be evaluated based on the results of TV-camera expansion inspection, with the assessment of individual pipes by the impact elastic wave method. This method made possible the quantitative identification of flaws that would affect the self-sustainability of the pipes (**Table-1**).
